## CONSERVATION TREATMENT RECORD

Lab number: 8429  
 Brief description: Cu Alloy Fitting  
 Name of owner: M. Millet, Thwing Archaeological Project  
 Owner's number: Th07 Small Find 176

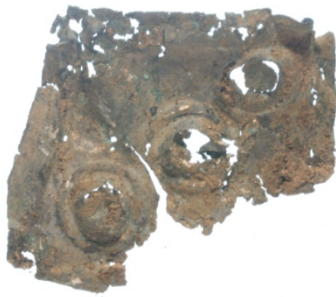
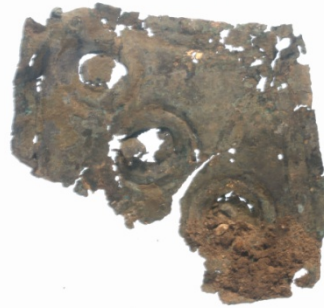
Before Treatment

<b>Material type</b> The fitting is made from a copper alloy. The metal is less than 1mm thick.	<b>Dimensions</b> Length: 4.2cm Width: 3.8cm Weight Before: 2.3g After: 2.1g
<b>Technology</b> The fitting was likely hammered flat and then stamped with a circular decoration.	
<b>Pre-treatment condition</b> The fitting was corroded with dirt and soil on the surface. It had been scratched down to bright metal in a few areas, and had many splits and small areas of loss throughout the fitting. There was one particularly large, stable crack between the bottom two pressed circles, and the metal was folded at the corners.	
<b>Significance</b> The brooch was excavated at Thwing, a Roman settlement in East Yorkshire. Artefacts from the first and second centuries AD have been found on the site, as well as a stone house dating to the late second or early third century AD. Although the object's original function is not clear, it was likely a decorative embellishment.

<b>Examination</b> The fitting was examined by optical microscopy. <b>Tests / analysis</b> The fitting was analysed using x-ray fluorescence spectroscopy.	
<b>Justification for treatment</b> Treatment was undertaken in order to remove dirt and soil remaining from burial, as well as to remove disfiguring corrosion in order to enable further study of the object as part of the Thwing Archaeological Project finds. Because of the colour of the exposed metal may lead to further investigation, the object was not given a protective surface coating.	
<b>Cleaning</b> Initially the object was submerged in industrial methylated spirits and cleaned using a soft brush. This was followed by careful mechanical cleaning under the microscope using a bamboo stick and a scalpel.	
<b>Stabilisation</b> N/A	
<b>Reconstruction / repair</b> N/A	
<b>Loss compensation</b> N/A	
<b>Other</b>	
<b>Packaging</b> The object was packaged in an inert plastic box with supportive foam for transport back to the owner and future

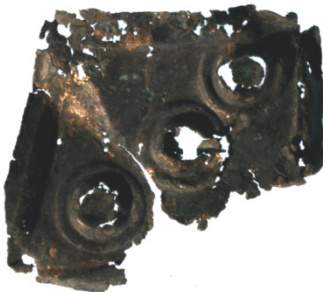
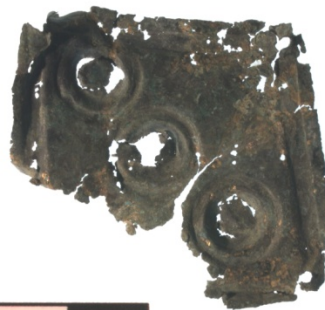
\nAfter Treatment

<p>storage. No silica gel was included as it is unlikely that it would be monitored or changed following the return of the object.</p>	
<p><b>Condition after treatment</b>  The object is in stable condition, and the excess soil and dirt has been removed from the surface. The surface has been cleaned down to a stable corrosion layer, and the decoration is more visible.</p>	
<p><b>Student evaluation of treatment</b>  The cleaning was successful in removing the obscuring elements and emphasizing the decoration and surface detail on the object. The corrosion layer was uneven throughout the surface of the object, and unfortunately a small amount of underlying bright metal was exposed during treatment.</p>	
<p><b>Recommendations for further care</b>  The object should be examined periodically for further corrosion. Although the object is stable, care should be taken when handling the object to prevent further folding or cracking of the metal.</p>
