**CONSERVATION TREATMENT RECORD**

Lab number: 7788

Brief description: Roman copper alloy trumpet brooch

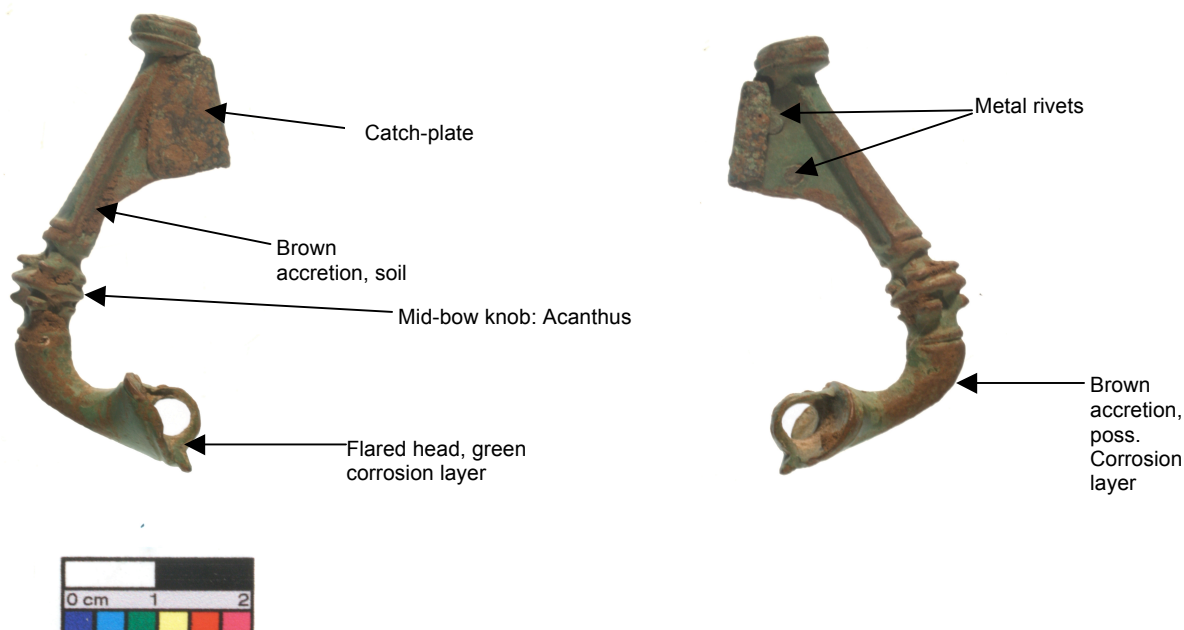
The object was in good condition although the spring and needle were missing from the bow of the brooch. The surface was moderately dirty.

<p>Examination</p> <p>Visual examination under the microscope</p> <p>Tests / analysis</p> <p>XRF: identification of difference in metals</p> <p>Main elements of bow of brooch (approximately):</p> <p>Cu – 70%</p> <p>Zn – 3%</p> <p>Ag – 0.06%</p> <p>Sn – 0.8%</p> <p>Pb – 7%</p> <p>Main elements of the catchplate:</p> <p>Cu – 72%</p> <p>Zn – 3.5%</p> <p>Ag - 0.1%</p> <p>Sn – 5%</p> <p>Pb - 3.5%</p> <p>Various layers and percentages of Paraloid B 44 (methyl methacrylate copolymer) were tested on similar metal in order to achieve a suitable appearance.</p>
<p>Justification for treatment</p> <p>Since the object will be returning to a private household without environmental control the protective coating of the object is justified. This is further backed up by the completed analysis of the metal composition. Since the object will be handled without gloves a corrosion inhibitor was avoided.</p>
<p>Cleaning</p> <p>Soil was removed from the surface of the object with a soft brush. No other methods were necessary.</p>

<p>Stabilisation</p> <p>A protective coating of Paraloid B 44 (methyl methacrylate copolymer) 5% w/v was applied in two layers to protect the metals from moisture and mechanical damage.</p>
<p>Reconstruction / repair</p> <p>N/A</p>
<p>Loss compensation</p> <p>N/A</p>
<p>Other</p> <p>N/A</p>
<p>Packaging</p> <p>The object was packaged in a crystal box (polystyrene). It was supported with plastazote (expanded cross-linked ethylene copolymers) and covered with acid free tissue paper for protection.</p>
<p>Condition after treatment</p> <p>The object has been cleaned and coated and is stable. Since it has been coated it should be safe to handle without gloves.</p>
<p>Student evaluation of treatment</p> <p>The object has been cleaned and coated successfully and is safe to handle without gloves.</p>
