## CONSERVATION TREATMENT RECORD

Lab number: 8781

Brief description: Roman brooch

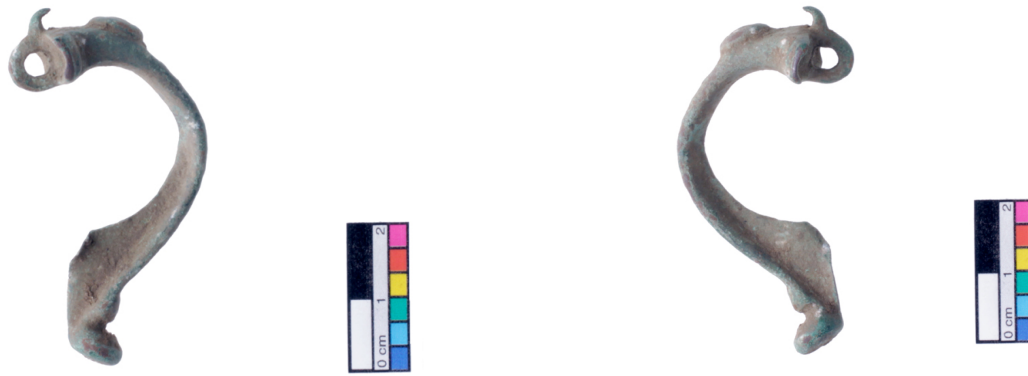
**Figure 3 Lab N. 8781. Before treatment. Front and back.**

- The pin is detached and missing;
- The edge of the catchplate appears irregular and slightly distorted, it is possible that a part of it is detached and missing.
- The body of the brooch appears sound, and the X-ray examination has shown no sign of cracks.

- The entire body of the object was covered by a layer of loose soiling.

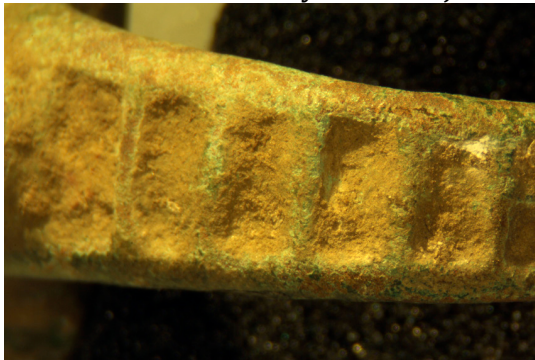
**Figure 4 Lab. N. 8781 Soil is banked up in the engravings.**

- Wet cleaning by cotton swabs with acetone, occasional use of wooden stick for breaking down bulky soiling deposits.
- Mechanical cleaning by scalpel for the decoration edges.

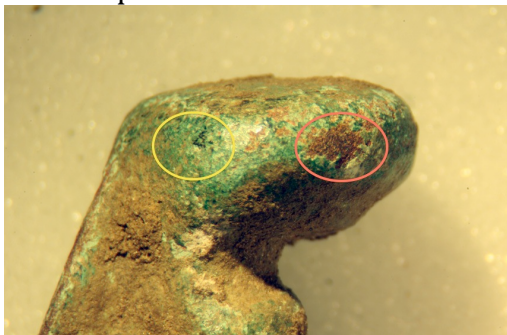
- A thin and regular light green patina; it is powdery and comes off easily.
- Spots of a harder, dark green corrosion product, possibly malachite, in areas where the superficial patina has come off.
- Spots of a red-brown corrosion product, possibly cuprite, underneath the malachite layer.

**Figure 5 Lab. N. 8781. A red layer of cuprite (circled in red) is present underneath a dark green layer of malachite (circled in yellow).**

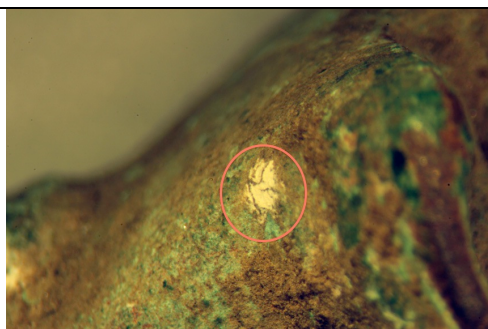
- Few small dots of white, powdery corrosion were present on top of the superficial light green patina; they may be chalk residues, original from the burial environment.

**Figure 6 Lab. N. 8781. White dots, probably chalk, were present on top of the light green patina.**

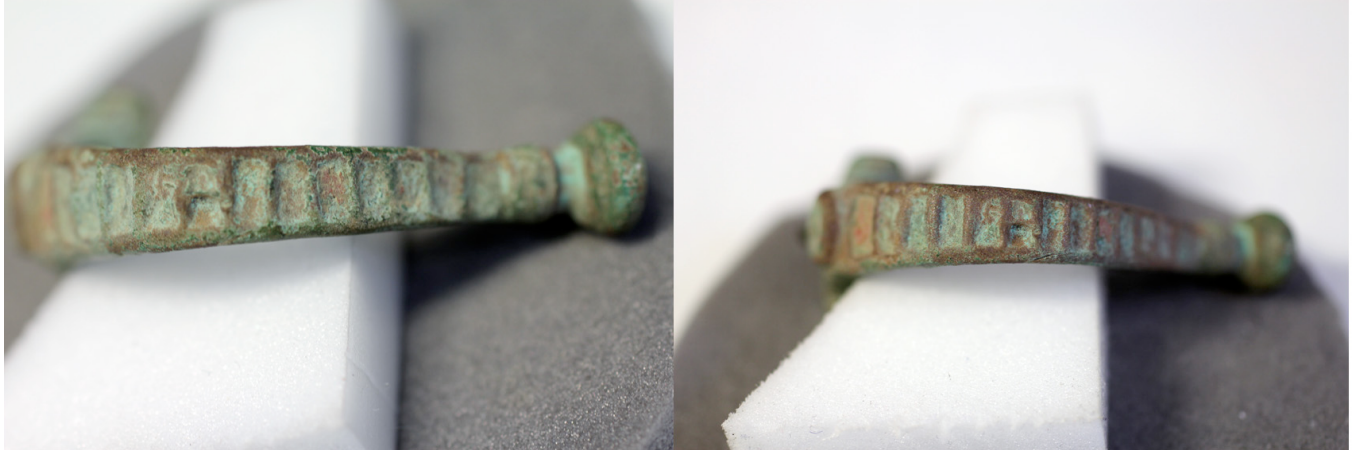
**Figure 7 Lab. N. 8781. The decoration edges have been mechanically cleaned by scalpel to improve legibility. Before (left) and (right).**

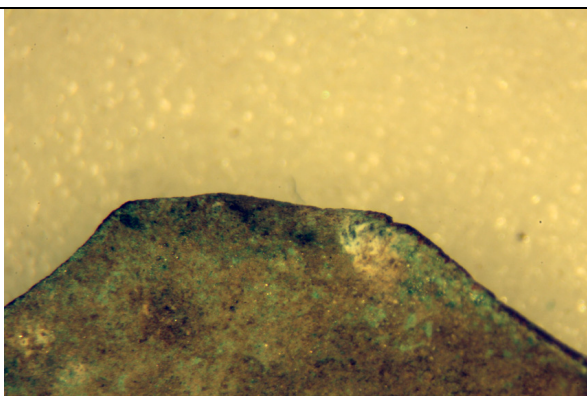
- The brooch is sound, and the X-ray examination has shown no sign of cracks.
- The pin is detached and missing;
- The edge of the catchplate appears irregular and slightly distorted, it is possible that a part of it is detached and missing.

**Figure 8 Lab. N. 8781. The catchplate edge is irregular and perhaps fractured.**

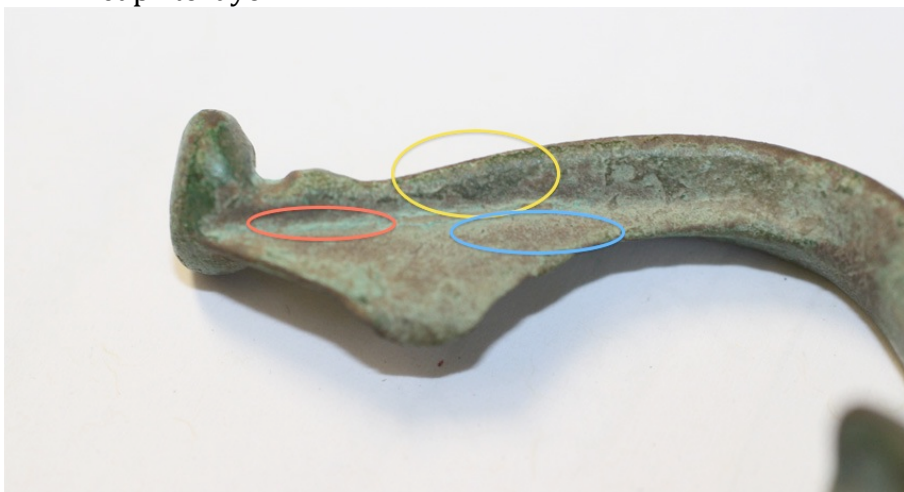
- A layer of red-brown corrosion product, possibly cuprite, covers most of the surface.
- A thin and regular light green patina is conserved in some areas, especially grooves and hollows.
- Few spots of a dark green corrosion product, possibly malachite, are present on top of the cuprite layer.

**Figure 9 Lab. N. 8781. After cleaning. Three different corrosion products are present on the surface: light green patina (circled in red), dark green corrosion, possibly malachite (circled in yellow) and red-brown corrosion underneath, possibly cuprite (circled in blue).**

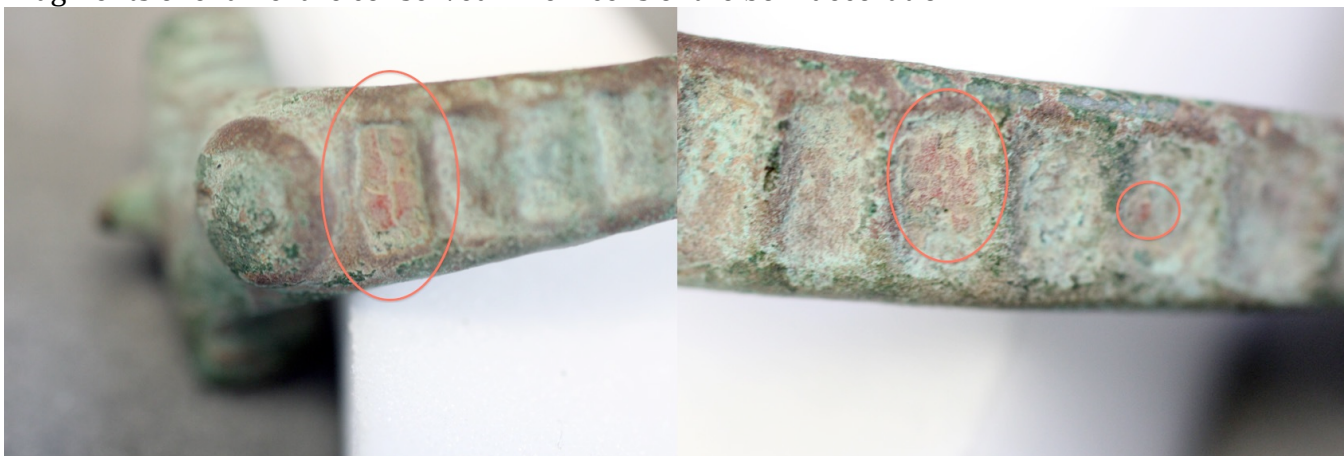
Fragments of enamel are conserved in few cells of the bow decoration.

**Figure 10 Lab. N. 8781. Fragments of enamel have been identified in three areas on the decorated bow.**
