Lab number: 8785  
 Brief description: copper alloy brooch(es)  
 Name of owner: Tim Schadla-Hall  
 Owner's number:

Name of student: Luciana Carvalho  
 Date allocated: 19/01/12  
 Date completed: 24/05/2012

Material type : Copper Alloy

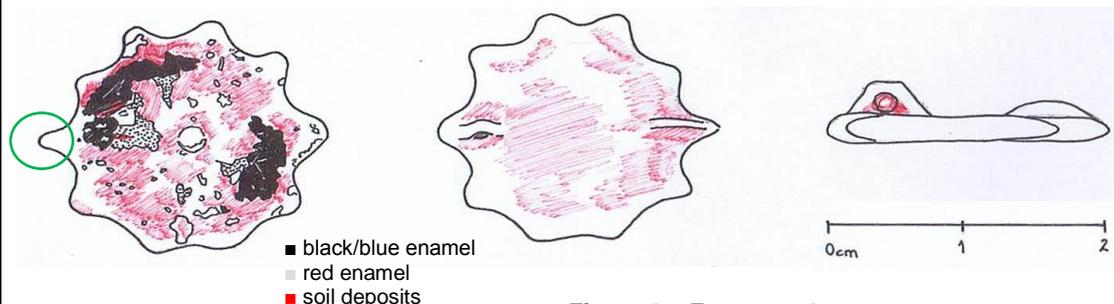
Figure 2 – Fragment 1

Fragment 1 (Figure 2) is a 10-lug flat disc hinged brooch decorated with concentric rings pattern of red and dark blue/black enamel - most of it missing - with a relief dot in the centre. The brooch's pin (missing) was originally on the back between two lugs. The lugs show various degrees of abrasion with the least abraded circled green on Figure 2a. Two of the lugs have almost disappeared, probably being the area exposed to the elements.

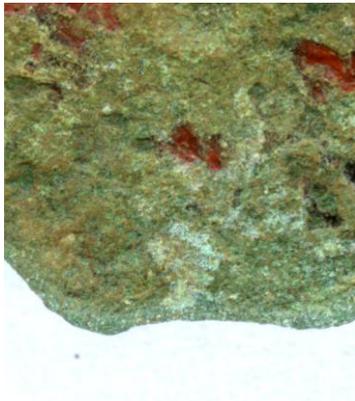
The fragment is lightly covered in soil (Figure 2) and corrosion products in various shades of green (figure 3a) mostly hard. At the back the corrosion layer appears more uniform, even appearing in crystalline form (figure 3b). The enamels have suffered fragmentation in the past but are now stable and firmly attached to the metal core. These enamelled areas are the original surface of the object. Below this surface there are some shallow craters filled with a powdery green corrosion (circled yellow in Figure 3c). The object as a whole has a matt appearance, except the enamelled areas which are vitreous, thus indicating the absence of a protective coating.

**Figure 3a – Fragment 1 front: corrosion products in various shades of green**

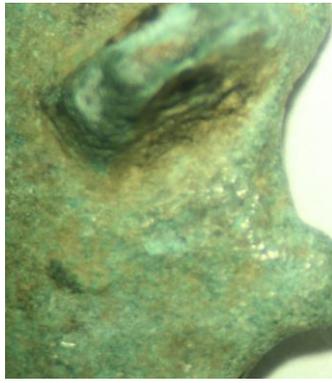
**Figure 3b – Fragment 1 back: corrosion products in crystalline form**

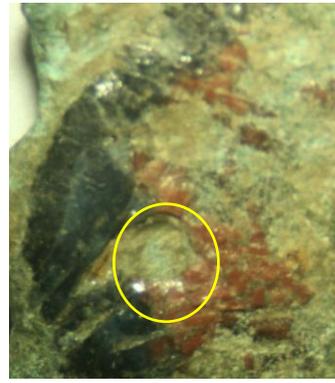
**Figure 3c – Fragment 1 front: detail of enamelled surface**

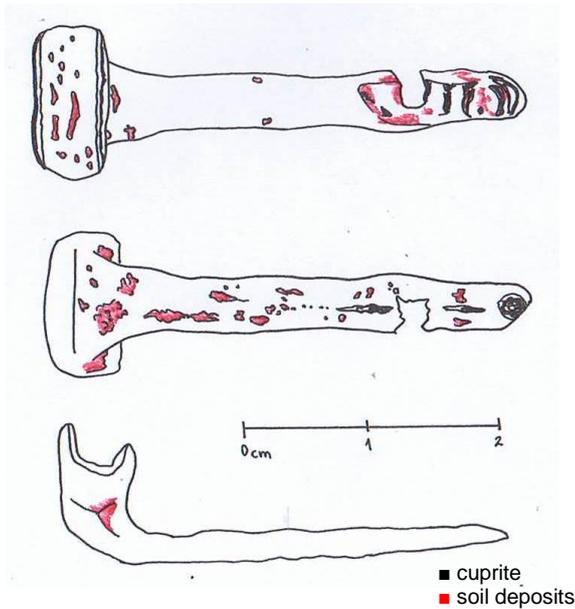
**Figure 4 – Fragment 2**

Fragment 2 (Figure 4) resembles a “T”-shaped brooch. There are soil deposits on the surface of the fragment over a layer of light green corrosion, some of which soft. Underneath there is a cuprite layer some of which exposed along the midrib (Figure 5a). The original metal is still visible where the cuprite layer has been lost (Figure 5b). Before the tip of the object there is an area of material loss (Figure 5c), possibly a broken side of a rivet hole. In its vicinity there are remains of a dark metal(s), possibly soldering.

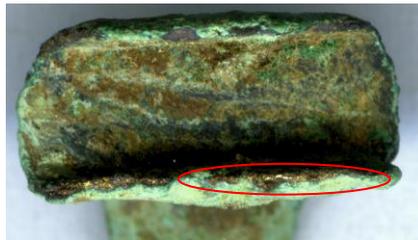
**Figure 5b – Fragment 2: exposed metal (circled red)**
