Metal Dusting of Heat-Resistant Alloys

University of Cambridge
Department of Materials Science and Metallurgy

A dissertation submitted to the University of Cambridge for
the degree of Doctor of Philosophy
October, 2008

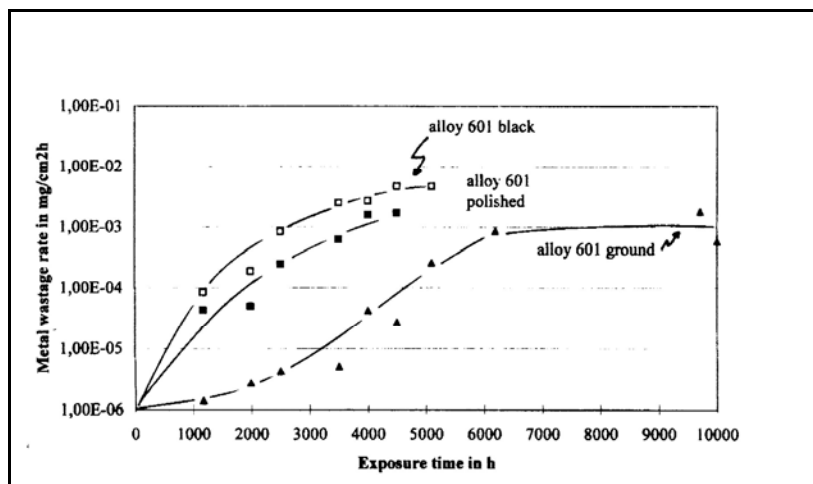
Figure 1.25 Metal dusting of alloy 601, with different surface conditions, after exposure to CO-H₂-H₂O gas at 650°C [18].

Klower *et. al.* [18] exposed commercial alloys to metal dusting conditions at 650°C for up to 10,000h. The alloys were Incoloy 800H, HK40, HP40, DS, alloy 600, alloy 601, C-4, 214, HR-160, 45-TM, alloy 602CA, alloy 617, and alloy 690. In the first 5,000h, the gas composition was 24%CO-74%H₂-2%H₂O and in the second 5,000h, the composition was changed to 49%CO-2%H₂-49%H₂O. The least metal wastage rates were observed on the alloys 45-TM, 690, and 602CA (Figures 1.25-1.27).

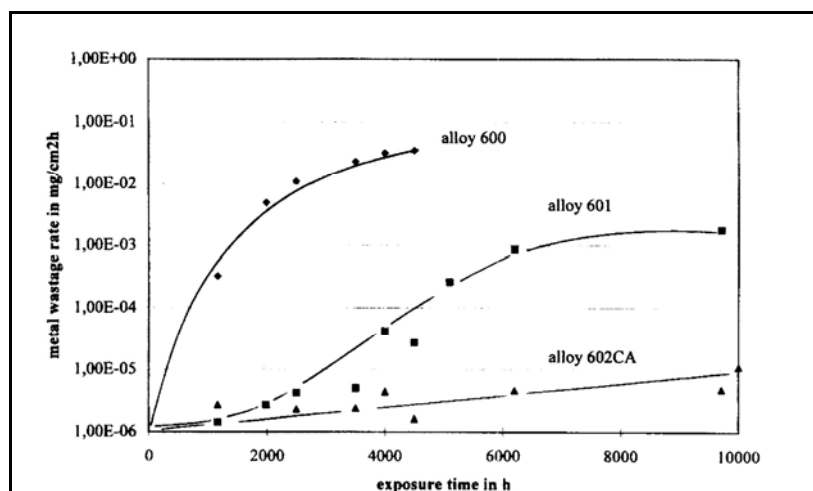
Figure 1.26 Metal wastage rate for nickel-based alloys exposed to CO-H₂-H₂O gas at 650°C [18].

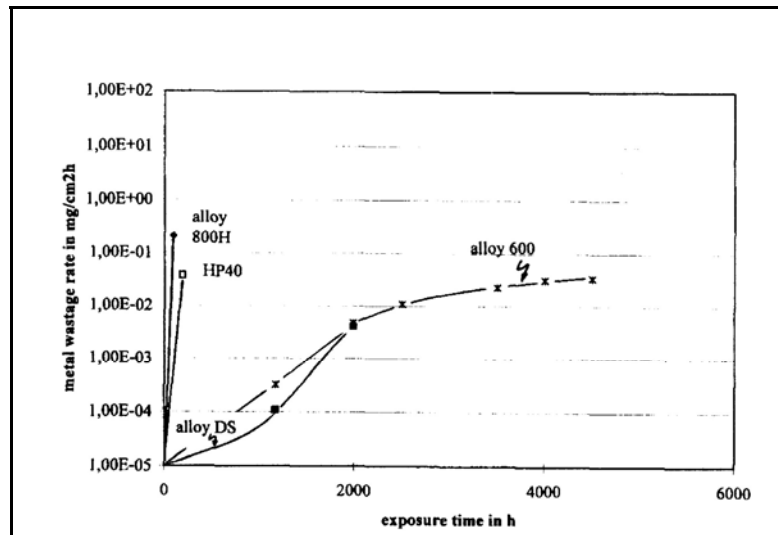
Figure 1.27 Metal dusting of iron-based alloys in comparison to the nickel-based alloy 600H after exposure to CO-H₂-H₂O gas at 650°C[18].

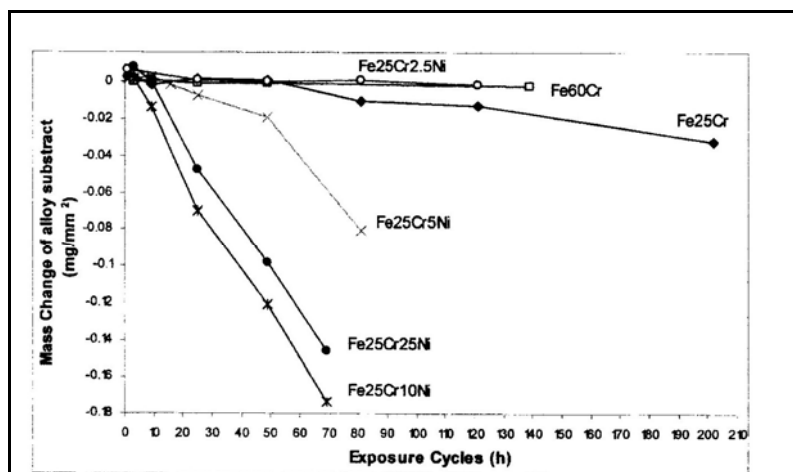
Figure 1.30 Mass change of the alloys due to the exposure to the metal dusting condition [51].
