# Improving Thermal Comfort in Low-income Tropical Housing: The Case of Uganda

Arman Hashemi<sup>1</sup>, Heather Cruickshank<sup>2</sup>, Ali Cheshmehzangi<sup>3</sup>

## Abstract

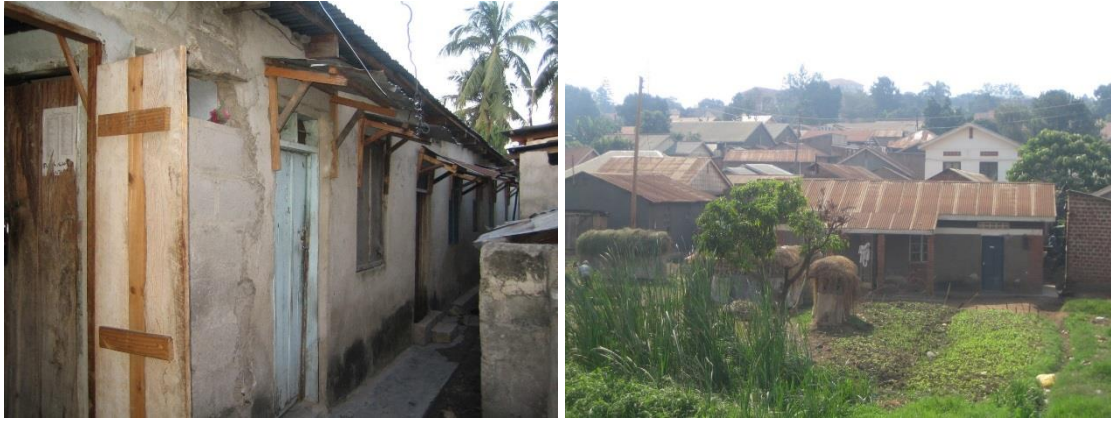
Figure 1: low-income housing with iron sheet roofing.

Figure 1 below also summarises the most common construction methods and materials used in housing projects during 2002-2010. In 2010, around 62% of homes in Uganda (84% in urban areas and 57% in rural areas) were roofed with iron sheets (Figure 2) followed by thatched roof which took a share of 37%. Around 57% (84% urban and 51% rural) of all dwellings had brick walls and 39% (12% urban and 46% rural) were made out of mud and poles. More than 71% of floors were made from earth (25% urban and 82% rural) and 27% (71% urban and 17% rural) were covered with cement (NPA 2010; UBOS 2010).

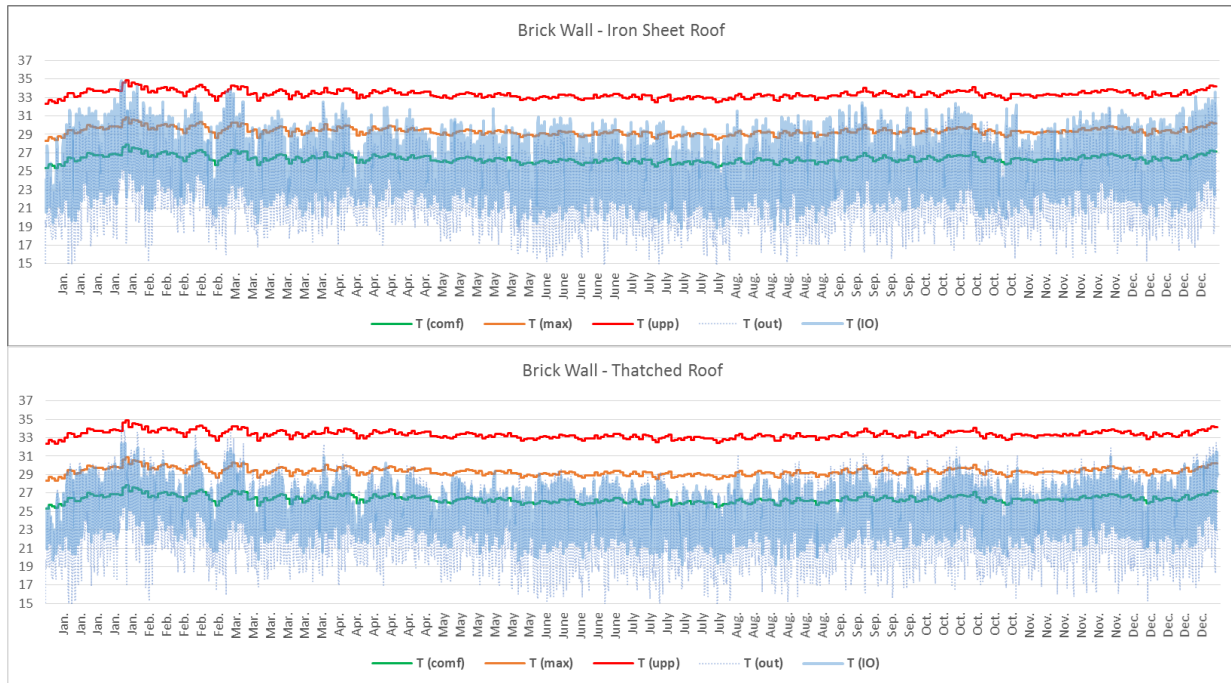
**Figure 4: Thermal comfort condition for brick walls with iron sheet (top) and thatched roofs (bottom).**

The results of simulations revealed that adobe and brick walls had similar performances although brick walls performed marginally better than adobe walls with iron sheet roof and slightly worse than adobe walls with thatched roof. Similar to adobe, brick walls with iron sheet roof failed in all three thermal comfort criteria. The building was thermally uncomfortable as the indoor operative temperature was in 8% of the occupied periods above the maximum acceptable levels. Moreover, for 56 days,  $W_e$  exceeded the acceptable limit. Regarding the third criterion, there were two days during which  $\Delta T$  exceeded the maximum acceptable temperature by more than the 4 K. Similar to adobe construction, the situation considerably improved for the thatched roof. The building passed criterion 1 and criterion 3 but failed in criterion 2 as there were 5 days during which  $W_e$  exceeded the acceptable limit. Figure 4 summarises the results of simulations for brick walls with iron sheet and thatched roof constructions.

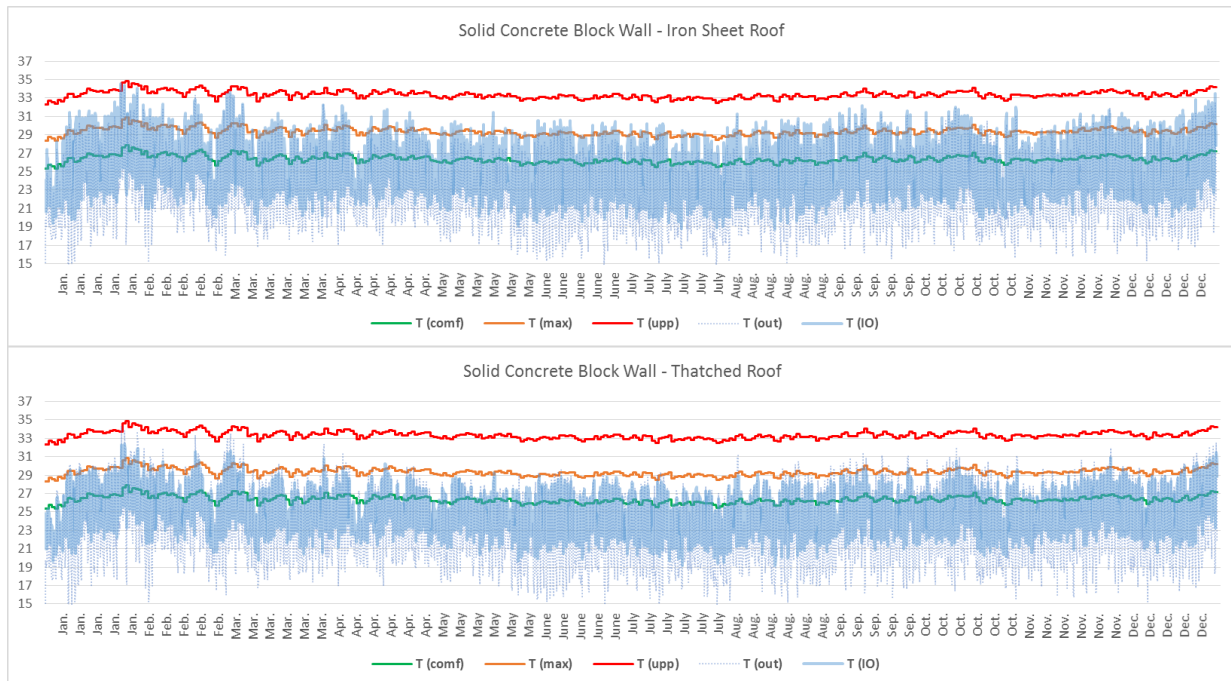
**Figure 6: Thermal comfort condition for solid concrete block walls with iron sheet (top) and thatched roofs (bottom).**

Solid concrete block walls had a comparable performance with adobe and brick walls. According to the results, the thermal performance of solid concrete block walls was slightly better than adobe and brick walls with iron sheet roofing system and slightly worse than adobe walls with thatched roof. Similar to other walling methods, solid concrete block walls with iron sheet roof failed in all three TM52 thermal comfort criteria; however, thermal performance of the building improved considerably with the thatched roof. For the iron sheet roof, the building was thermally uncomfortable during 7% of the occupied periods and  $W_e$  exceeded the acceptable limit for 45 days. Moreover, there were two hours during which  $\Delta T$  exceeded the 4 K limit. For the thatched roof construction, the building passed criteria 1 and 3 but failed criterion 2 by five days during which  $W_e$  exceeded the acceptable limit. Figure 6 summarises the results of simulations for solid concrete block walls with iron sheet and thatched roofs.
